CHURCH OF THE HOLY SEPULCHRE JERUSALEM

STRUCTURAL SURVEY
FINAL REPORT

BY
WILLIAM HARVEY

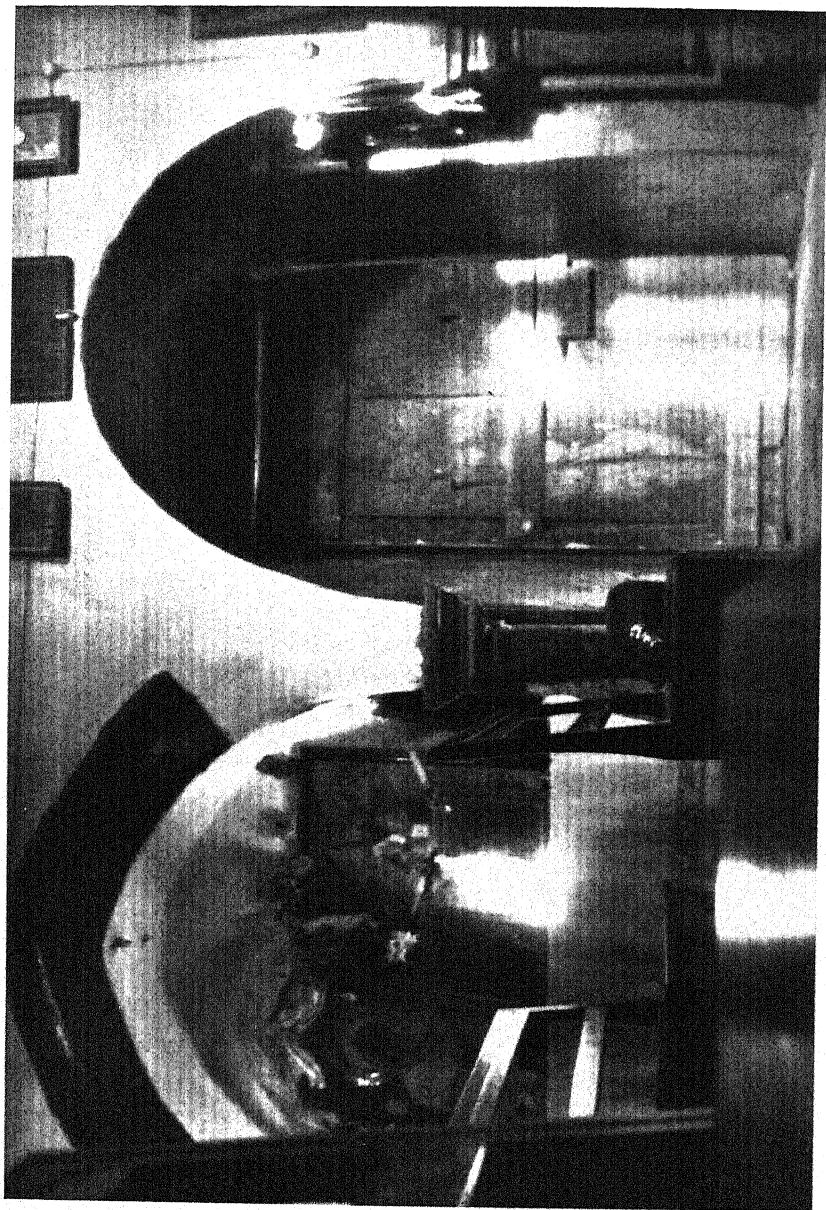
FIG. 101. WINDOWS TO STAIR IN TOWER

(16) Reopening of blocked door to spiral staircase of Tower in West wall of Chapel of the Forty Martyrs, and small windows above, to stair (see Figs. 101, I, 31).

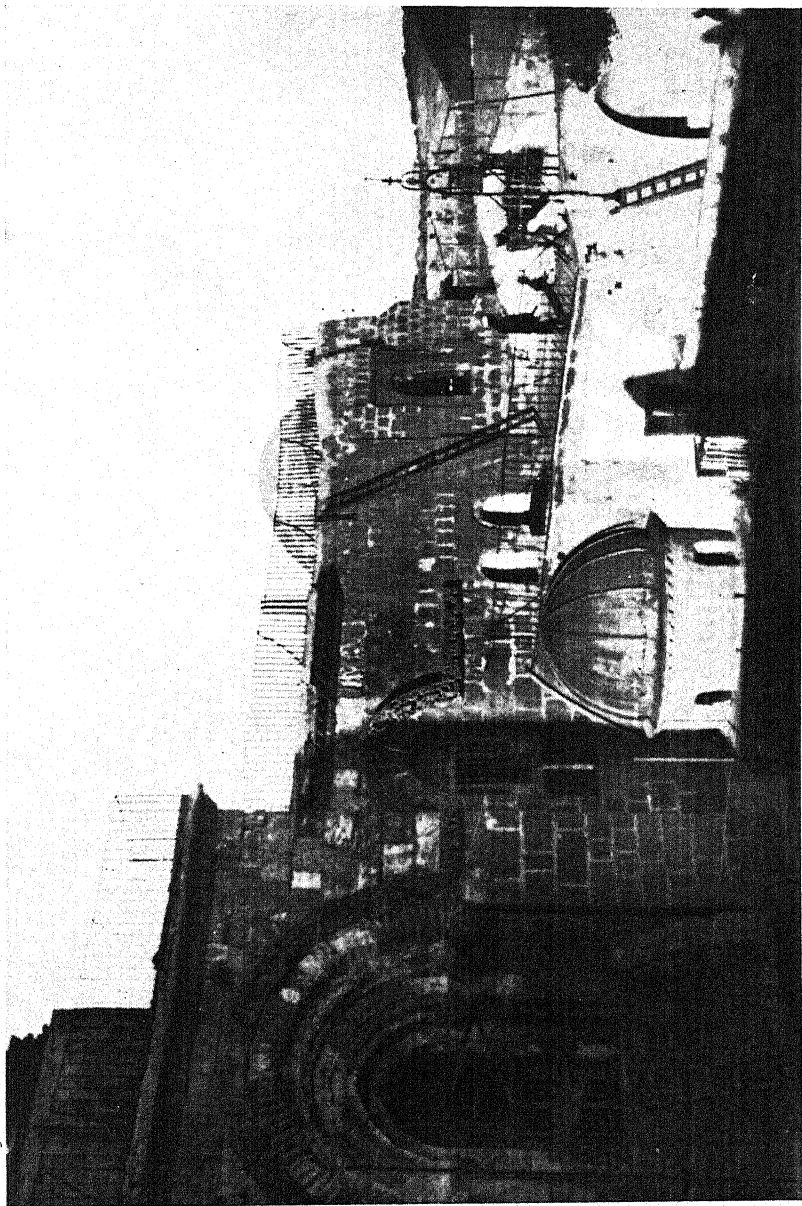
FIG. 102. WALL ARCADE, CHAPEL OF ST. JAMES

(17) Reconditioning of arcaded wall and recesses in the Chapel of St. James (at the South-west angle of the Parvis) (see Figs. 102, I, 33-V).

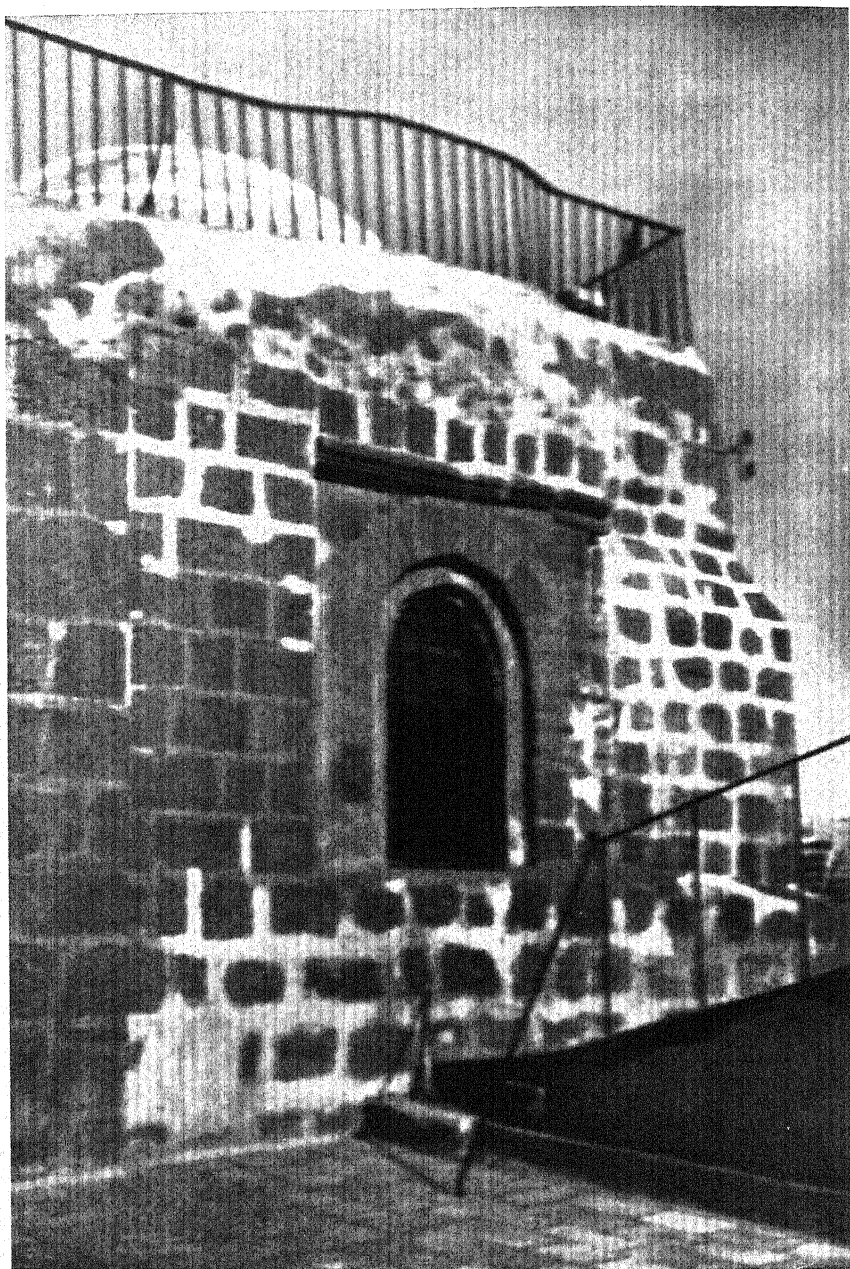
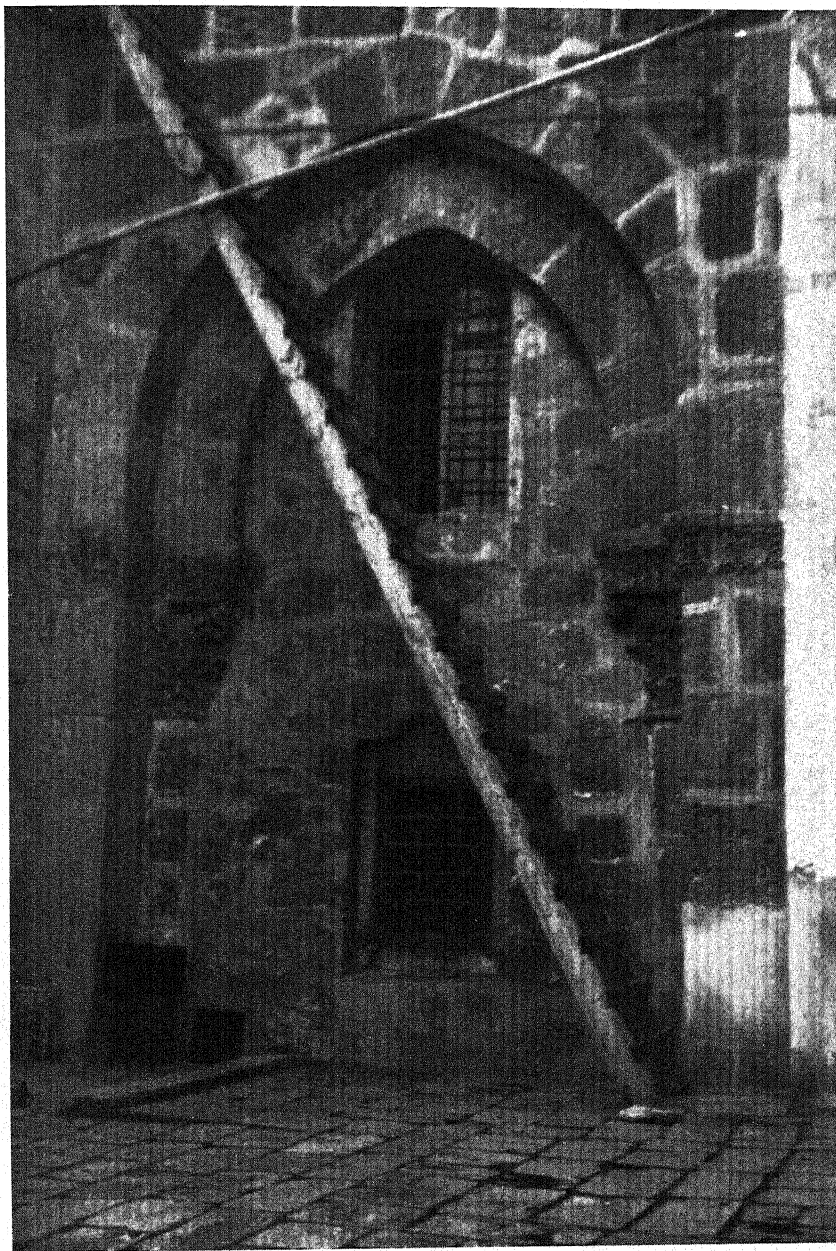
(18) Removal of modern accretion from beneath Byzantine octagonal cupola to east of Chapel of Melchizedek, and opening of old window in its South-east wall (see Figs. 103, 104, II, 12).

FIG. 103. SOUTH-EASTERN ANGLE OF BUILDINGS

FIG. 104. BYZANTINE OCTAGONAL CUPOLA

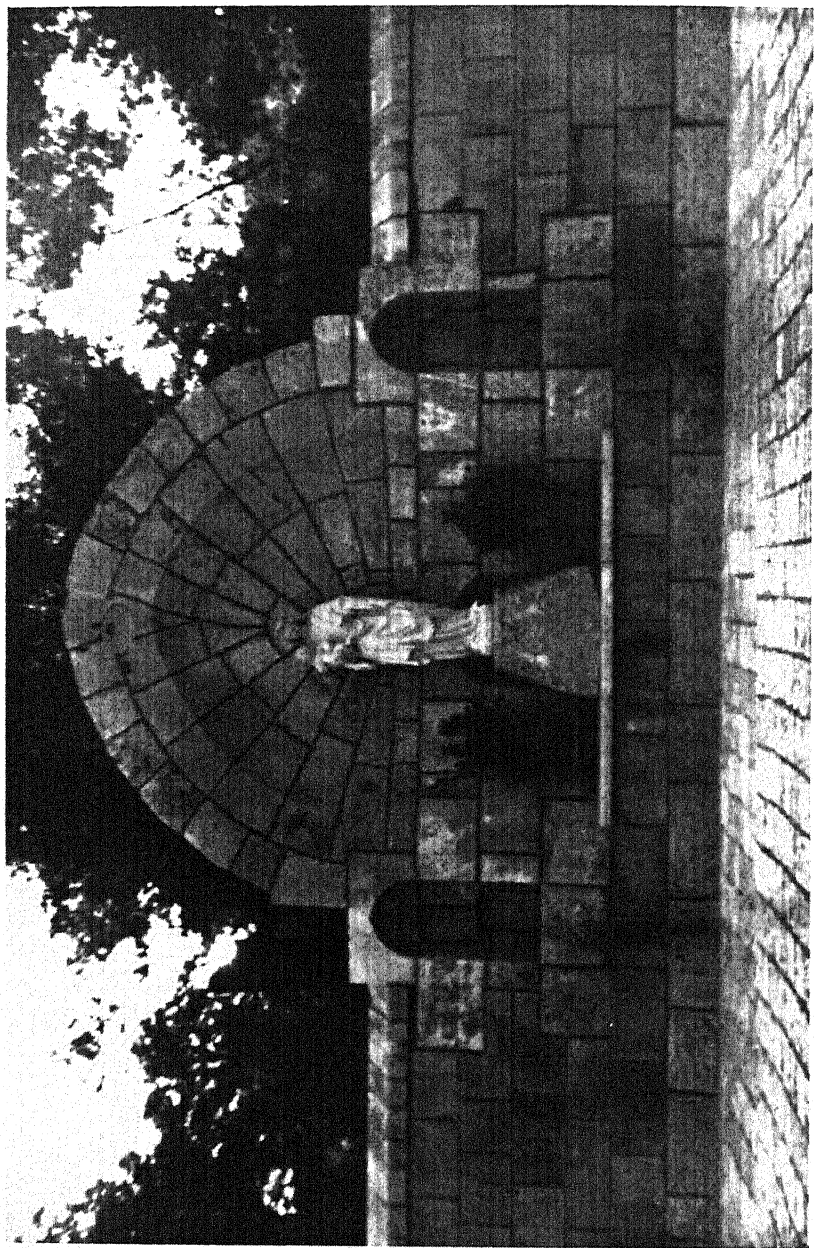
FIG. 105. OLD DOOR TO UPPER AMBULATORY

(19) Removal of modern floors and partitions inside old arch of upper ambulatory, leading to the Greek Terrace, and reopening of arch as a doorway (see Fig. 105).

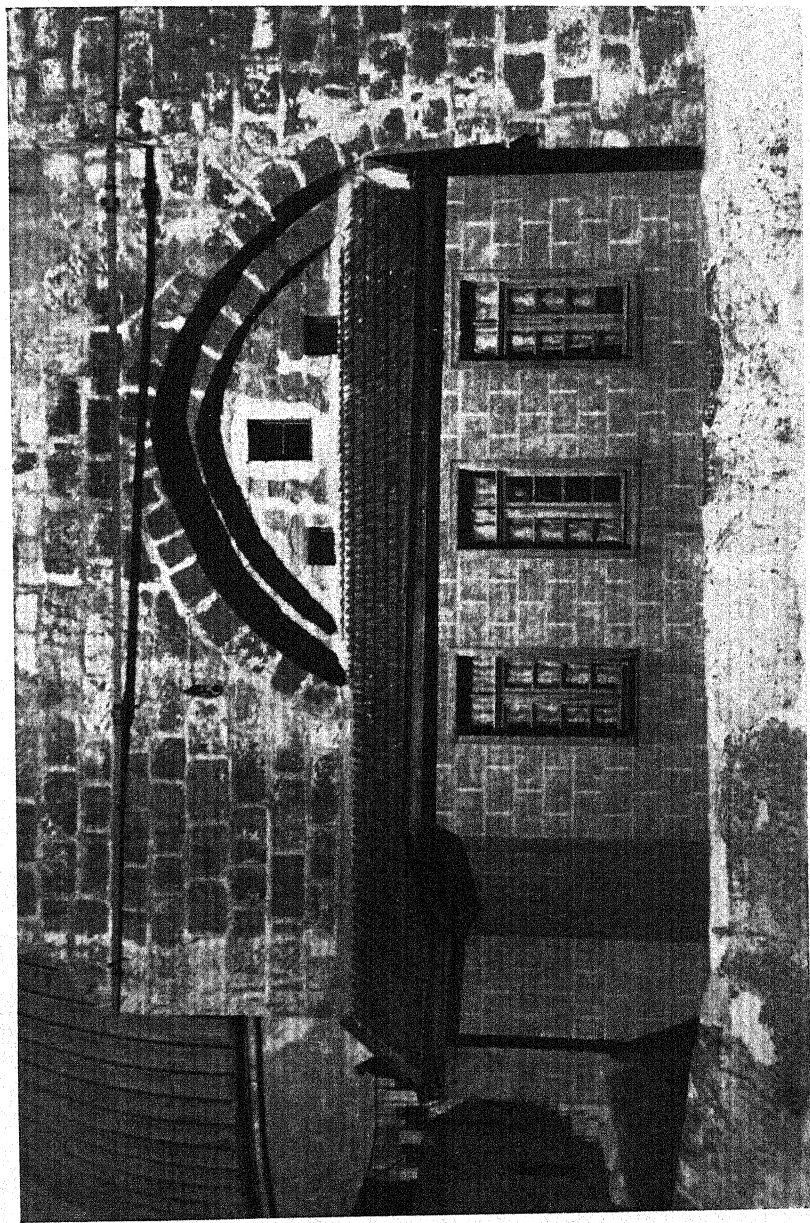
FIG. 106. NICHE FROM ROOF BY ROTUNDA, NOW AT ST. ANNE'S

in 1870 and its restoration to its original position on the roof of the Rotunda gallery, as a window opening through the upper blind arcade of the Rotunda drum (see Fig. 106).

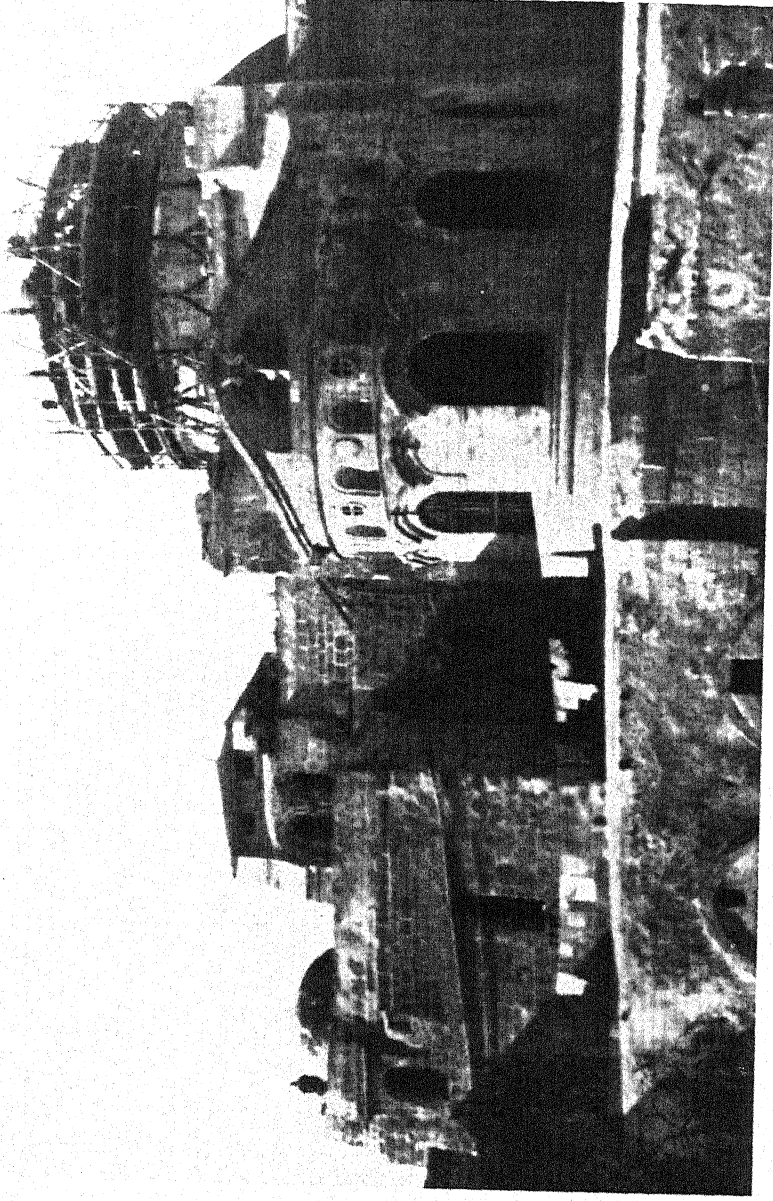
FIG. 107. MODERN ROOM ATTACHED TO TOWER

(21) Removal from the South face of the Tower of the modern room added to the floor above the vault of the Chapel of the Forty Martyrs (see Fig. 107).

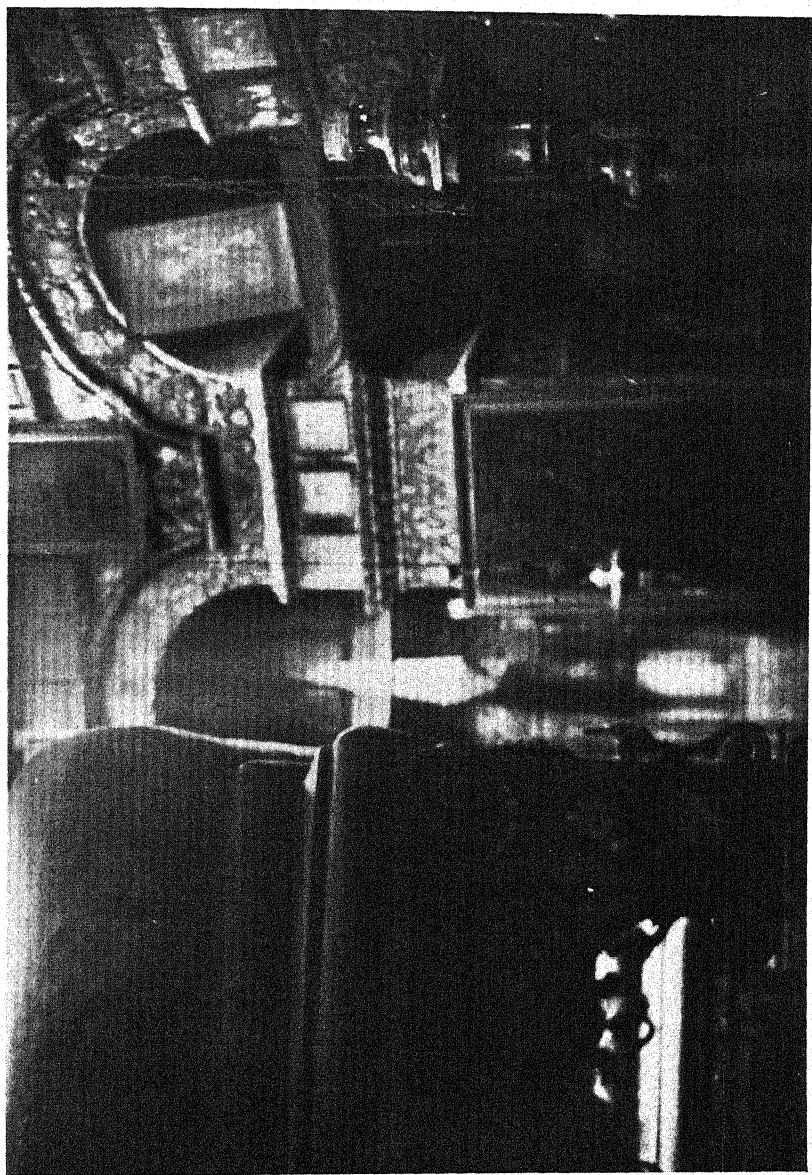
FIG. 108. EAST END

(1) During the reconstruction of the apse, made necessary by its decay, it should be redesigned as far as possible according to its original form, and, in any case, to harmonize with the general design of the building (see Figs. 108, 110, I, 6).

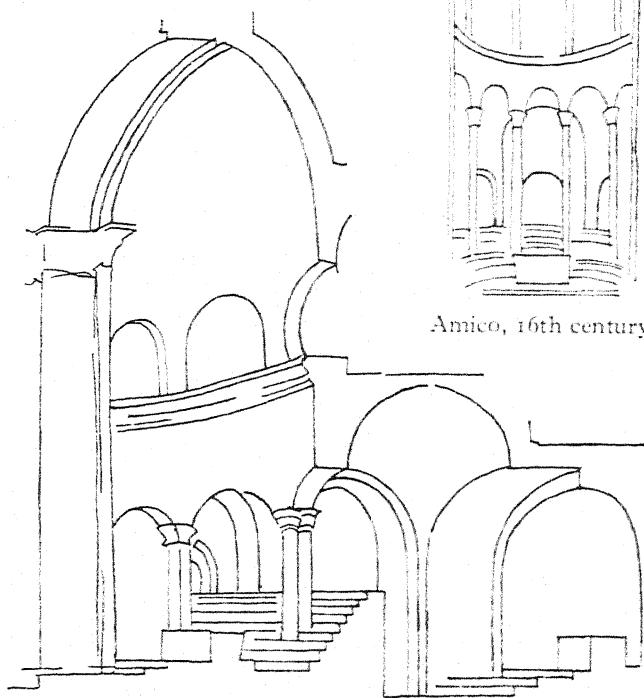
(2) It will probably be found that the original twin columns of the lower apse arcade exist inside the present square piers. If so, they should be revealed, and reconstructed if necessary to bear the load. In any case, twin columns following the original design should be substituted for the massive piers (see Figs. 109, 110).

FIG. 109. PIERS OF APSE, AS BUILT IN 1810

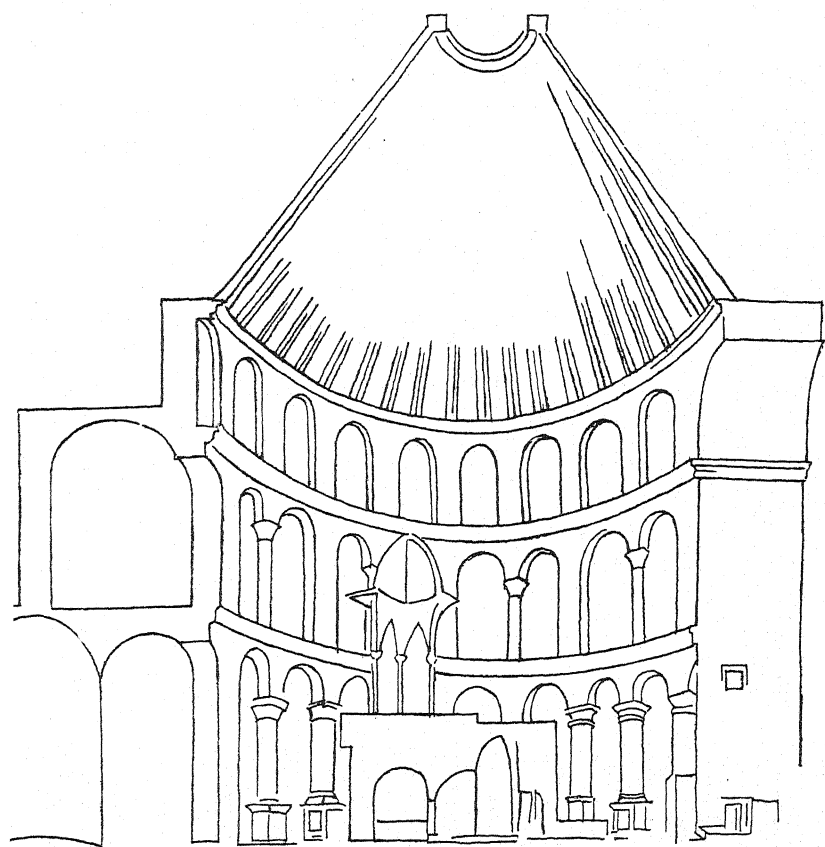
(4) Should remains be found during the work of repair in the Rotunda piers, of the original columns, they should be reconstructed, and the arcade and galleries returned as nearly as possible to their original Byzantine form (see Fig. 113).

(4) The removal of the present dome over the Rotunda and its replacement by a cone following the original design, which was adhered to in many rebuildings up to the fire of 1808 (see Figs. 113, 118).

FIG. 113. AMICO'S SIXTEENTH-CENTURY DRAWING
OF THE ROTUNDA

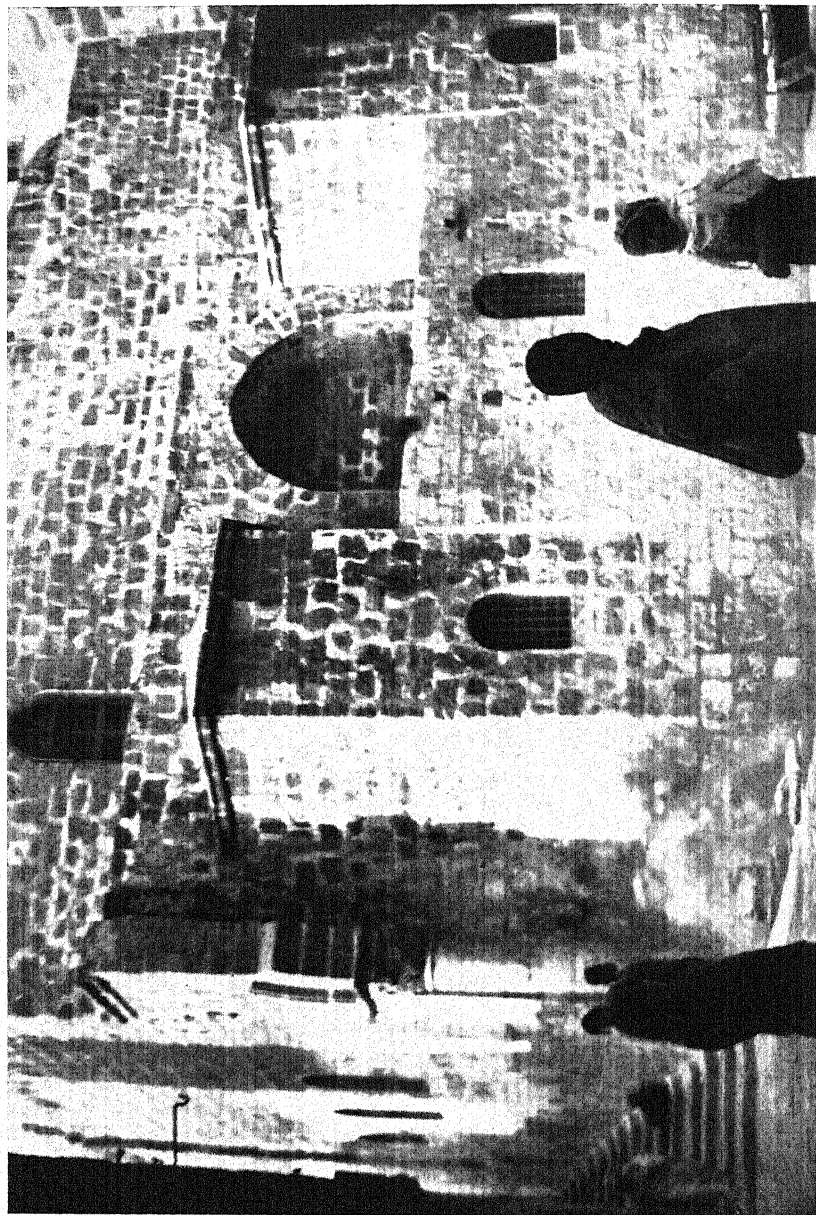
FIG. 114. WEST SIDE OF PARVIS

Parvis, from the present remains: the western half pier and portion of one arch, with above it a fragment of the original crowning mouldings of the arcade, and the bases still *in situ* (see Figs. 114, I, 41).

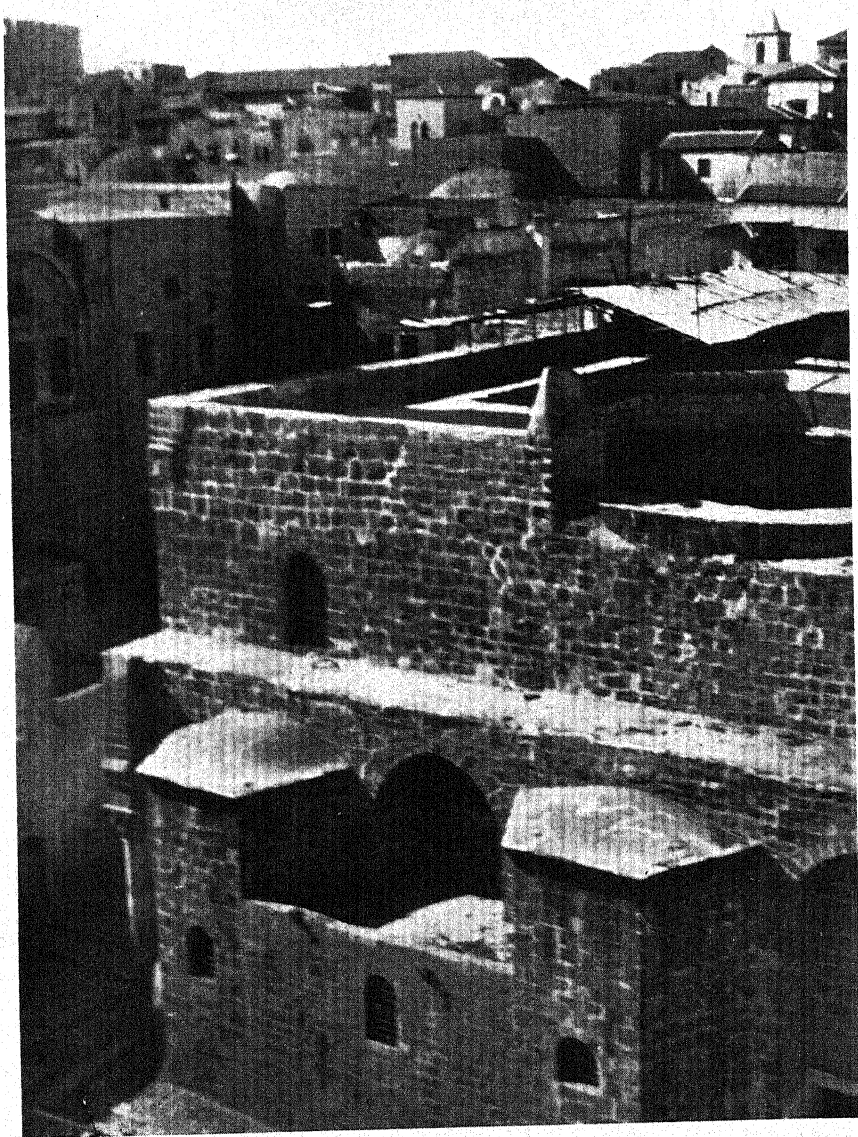
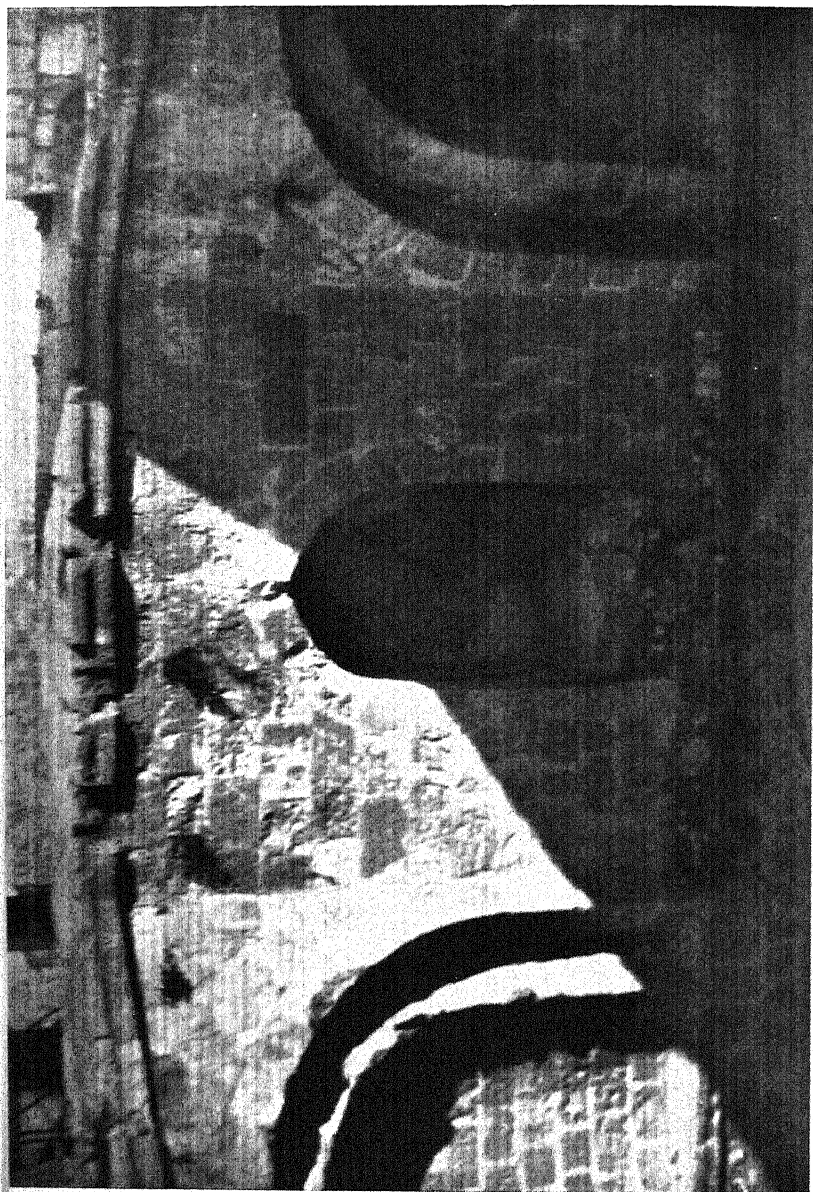
(2) The rebuilding of the dome over the old Baptistery south of the Tower, and the subsequent removal of the lower vault which partially covers the space at present; also the opening of the blocked window in the eastern face (see Figs. 115, 116, I, 32-II, 19).

FIG. 115. OLD BAPTISTERY, ETC., FROM ABOVE

FIG. 116. EAST WALL, OF OLD BAPTISTRY FROM WITHIN

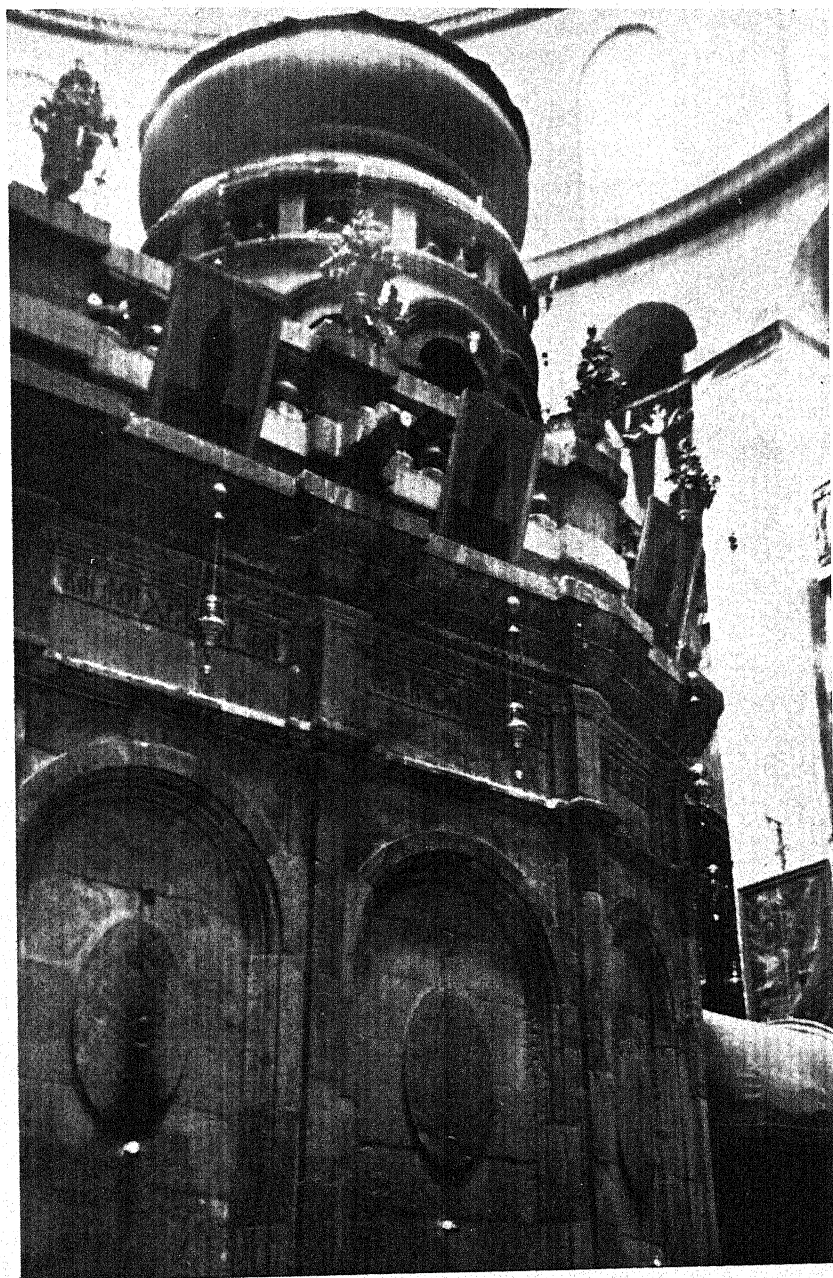
FIG. 119. THE EDICULE OF THE SEPULCHRE

As the edicule of the Sepulchre itself does not form part of the fabric, it has not been mentioned in the body of this report. Its state is, however, one of serious decay, and steps should be taken to secure it from sudden collapse.

It seems very doubtful whether its age is sufficient to justify its retention in the event of extensive repair or alternative demolition being in question. Its design (see Fig. 119) is completely out of keeping with the original Church, and would appear still more so if the suggested alterations take place, restoring to the building as far as possible its earlier form.
